Testing ROCKWOOL insulation from CPH airport hangar 4

January 2023

1. Introduction

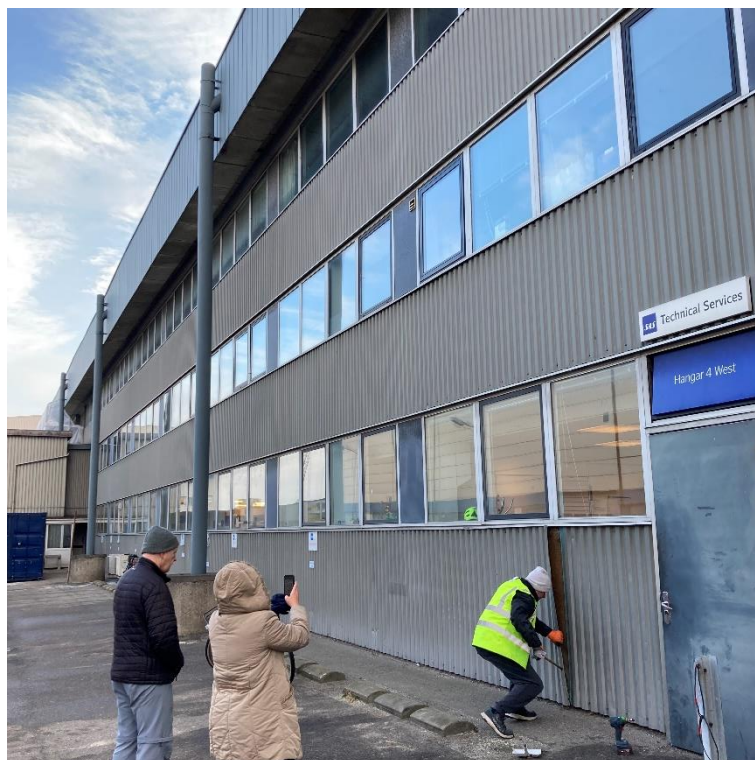
Figure 1. Photo of CPH Hangar 4. Insulation samples were covered by trapezoidal metal wall panels.

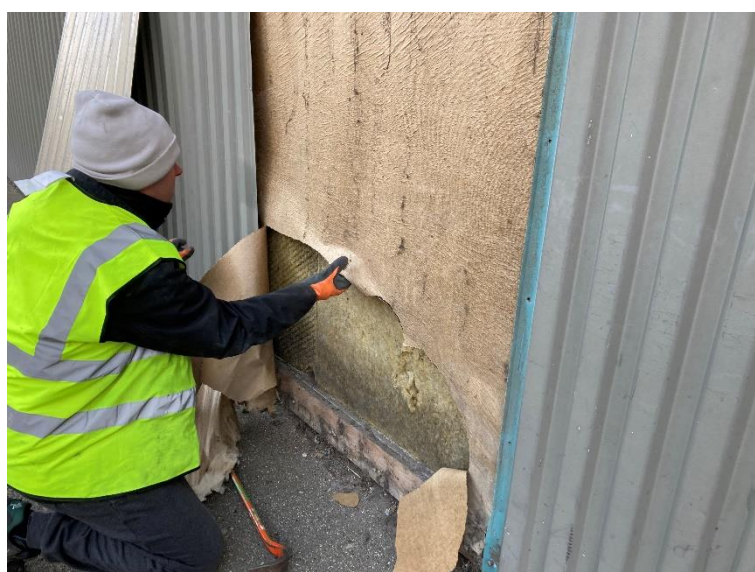
Figure 2. Insulation slabs behind trapezoidal metal wall panels and cardboard wind-stop.

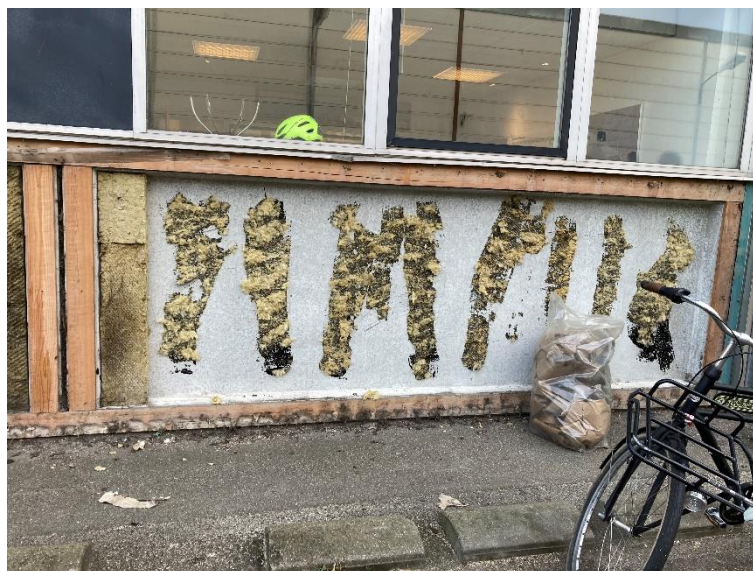
The sampling took place December 14th, 2022, at Copenhagen airport, Hangar 4 (built in 1958). 15 full size samples of insulation slabs were taken from the façade of the building (see Figure 1). 5 slabs were used for testing at DTI and the remaining 10 were delivered to ROCKWOOL. The insulation slabs were oriented vertically and covered by trapezoidal metal wall panels and a layer of cardboard wind-stop (see Figure 2). The inner side of the insulation slabs were partially glued to the building wall, therefore extra care should be taken during the dismounting process to avoid unnecessary damage of the slabs (see Figure 3). No water damage has been observed and all slabs were evaluated OK.

Figure 3. Insulation slabs were glued to the wall.

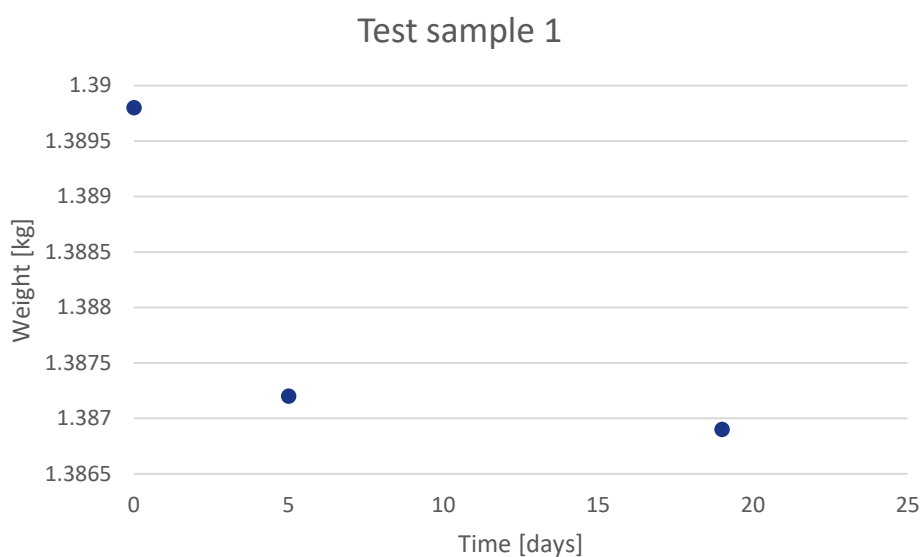
The duration of the conditioning was 14 days. In this period the weight of each slab was measured three times: at arrival, at five days after arrival and at 14 days after arrival. The weight loss during the last 14 days was less than 0.05 %.

Figure 4. Example of weight measurement for one slab.
