Durability Project Mineral wool

Report on findings E3.3-2016/01

Subject: Durability Project Mineral wool

Report No.: E3.3-2016/01

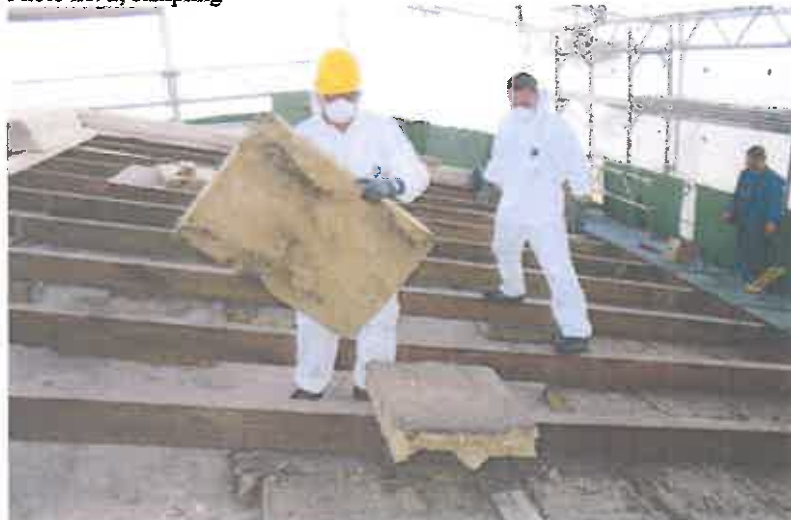
Pre-sampling history The Building is under refurbishing. The insulation was placed above a concrete roof with a slope at approx. 15 degree. Above the insulation there was a cavity approx. 200 mm, presumable well ventilated. The top of the roof was a wooden construction originally with most probably a bitumen roofing. The condition of the insulation may have been influenced by leaks in the roof. Most of the surface of the insulation has marks and small scars.

Photo no. 2, sampling

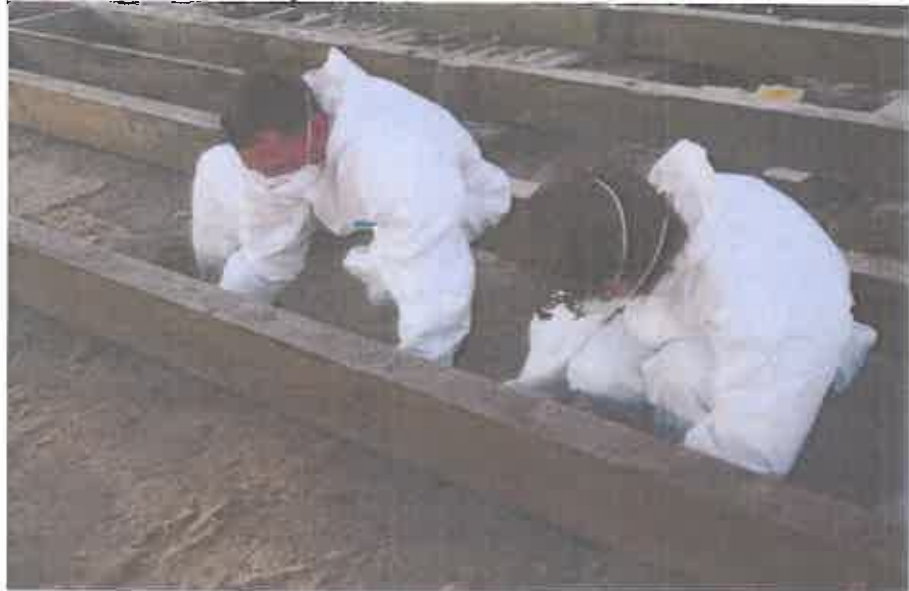
Photo no. 3, Removal of samples

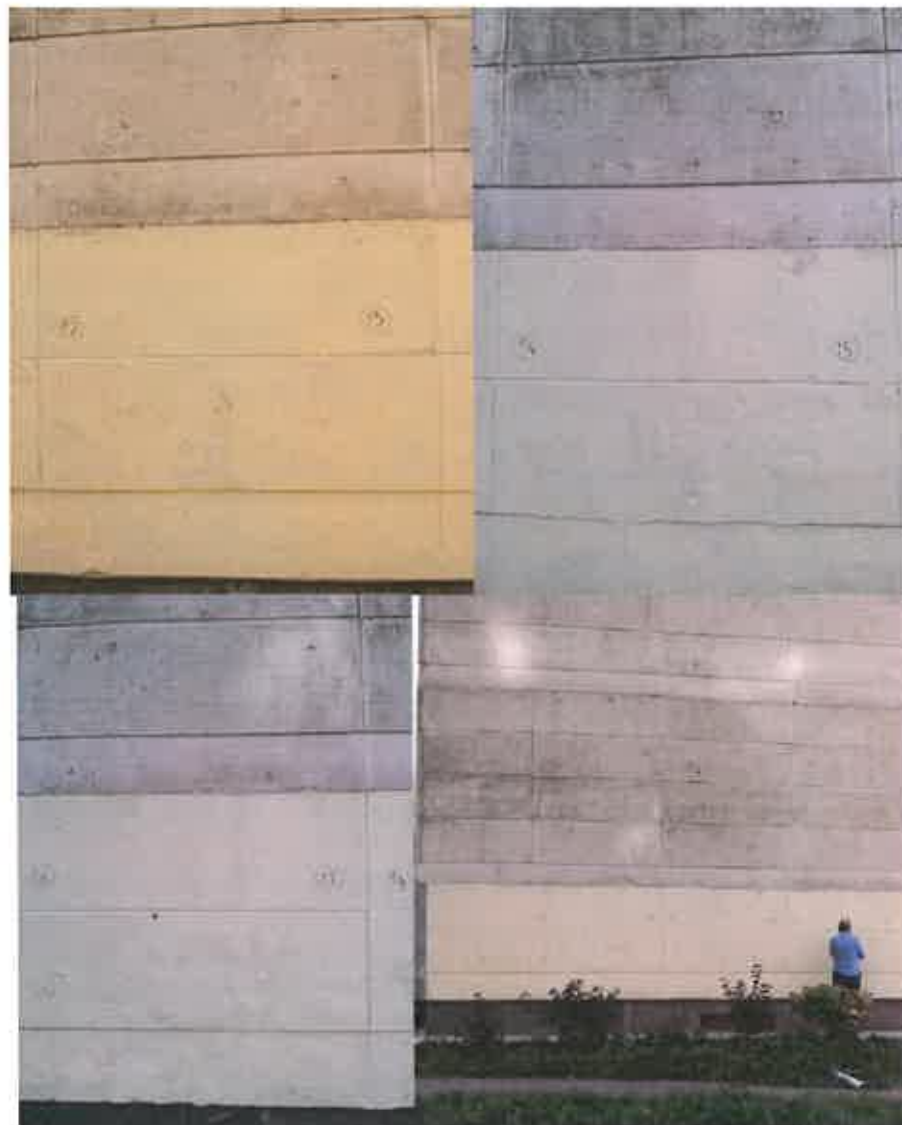
Samples were taken from the North-west orientation façade of building: No12; No13; No14; No15; No16; No17 (Figure 6). The specimen No17 was prepared for determination of moisture content.

**Figure 6. Samples were taken from the North-west orientation façade of building: No12; No13;
No14; No15; No16; No17**
