Energy-efficiency Up-grade with Pre-fabricated Façade Elements – the Innova Project Renovation in Saturnuksenkatu 2, Riihimäki

Kimmo Lylykangas,
architect SAFA
Kimmo Lylykangas
Architects, Finland
*kimmo.lylykangas@
arklylykangas.com*

Summary

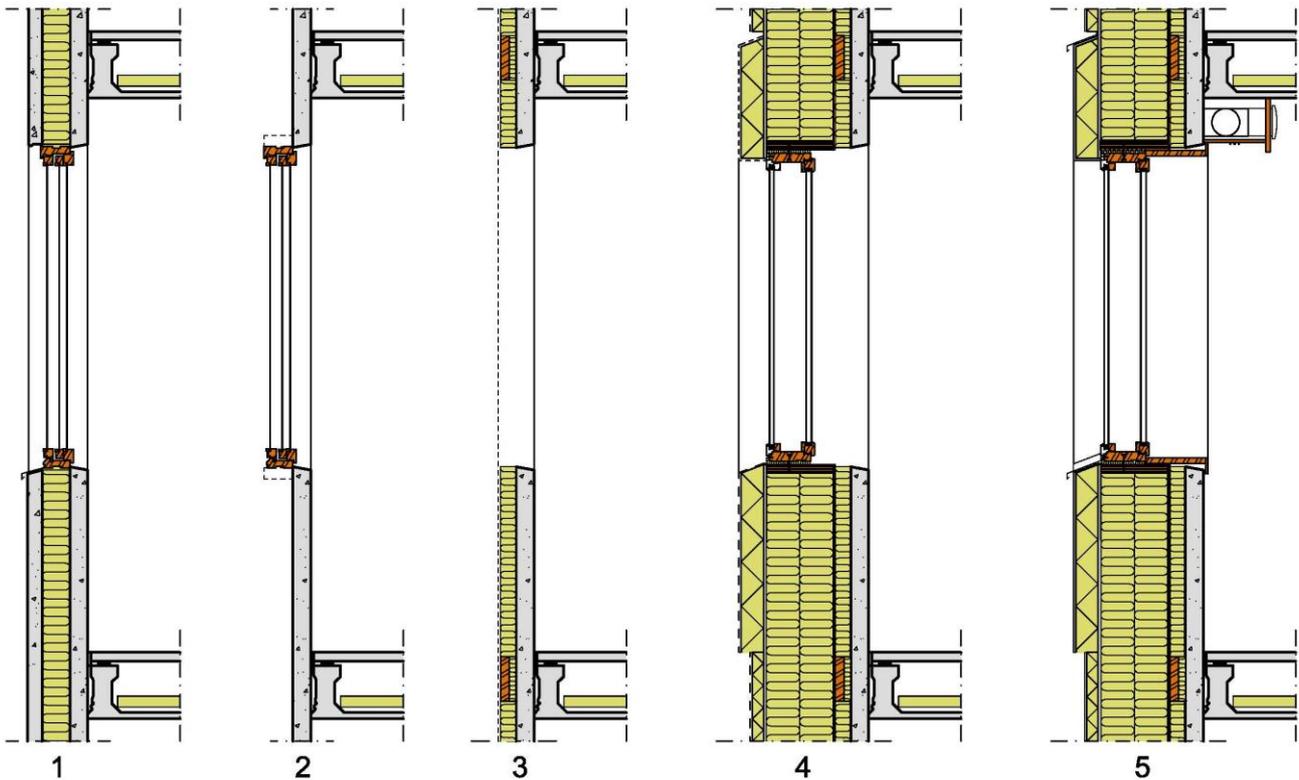
Fig. 2 The outermost concrete layer of the sandwich element is dismantled (2) and the existing thermal insulation removed. 70 mm of thermal insulation is mounted on the concrete surface (3) to make the surface even enough for the elements. The facade element (4) has 350 / 400 mm of thermal insulation. The windows, the balcony doors and the vertical ductwork for the supply air are installed in the elements. The finishing work is done on site (5). Image: Kimmo Lylykangas Architects.

The most multi-storey houses in the Peltosaari area are typical 1970s buildings. The facades are usually built of pre-fabricated sandwich elements. The outer concrete pane of the sandwich element needs to be supported or replaced, since the strength of the metal connectors between the panes is reduced by the corrosion. The 70s buildings are currently being renovated also in Peltosaari. Typically the outermost layers of the old facades are dismantled, new thermal insulation with plaster rendering added and new windows, doors and balconies installed. Since the flat roofs have had leakages, they are often replaced with a new roof with eaves and an external rainwater system.

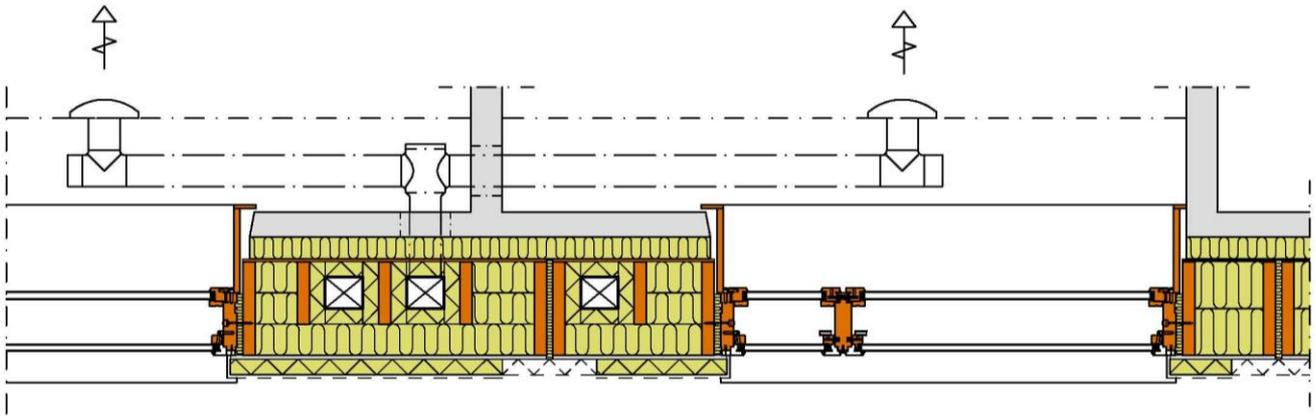
Fig. 4 The vertical ventilation ducts for the supply air are installed in the elements.

The vertical ductwork for supply air is built in the elements. Two rectangular dimensions, $100 \times 120 \text{ mm}$ and $100 \times 150 \text{ mm}$ are used for the rooms in the apartments. Two larger dimensions, $100 \times 200 \text{ mm}$ and $100 \times 250 \text{ mm}$, are used for the vertical ventilation ducts of the day-care center. The exhaust air is led out through the existing ductwork.
